James Brice House, Annapolis MD. c. 1773

Paint Removal, Stabilization, and Repairs on Dining Room Cornice

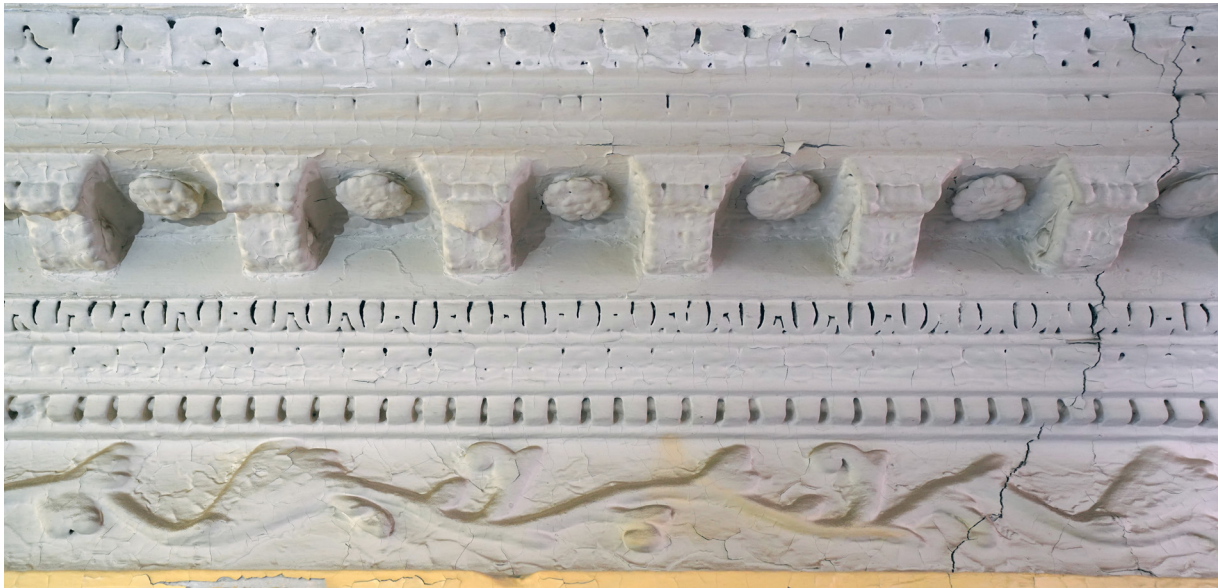
Before treatment

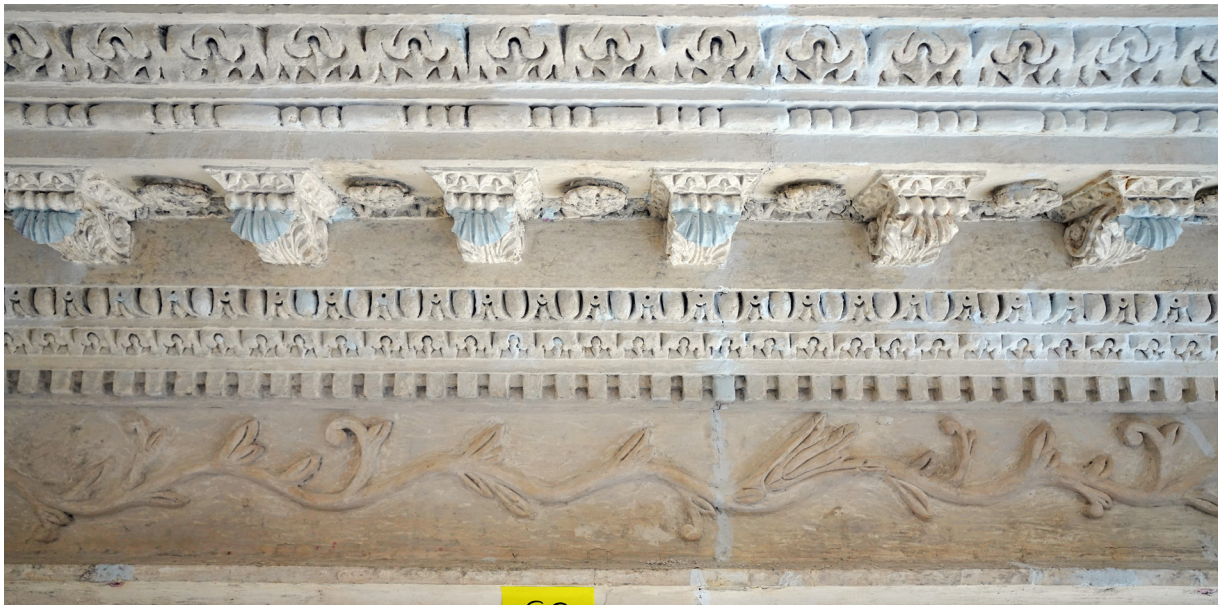
After paint removal and repair

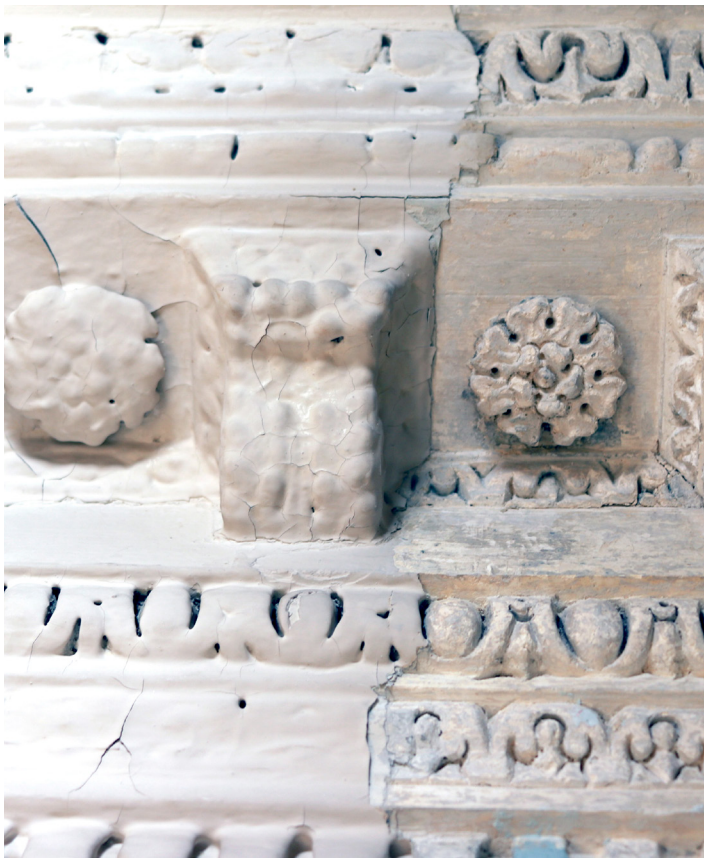
During treatment

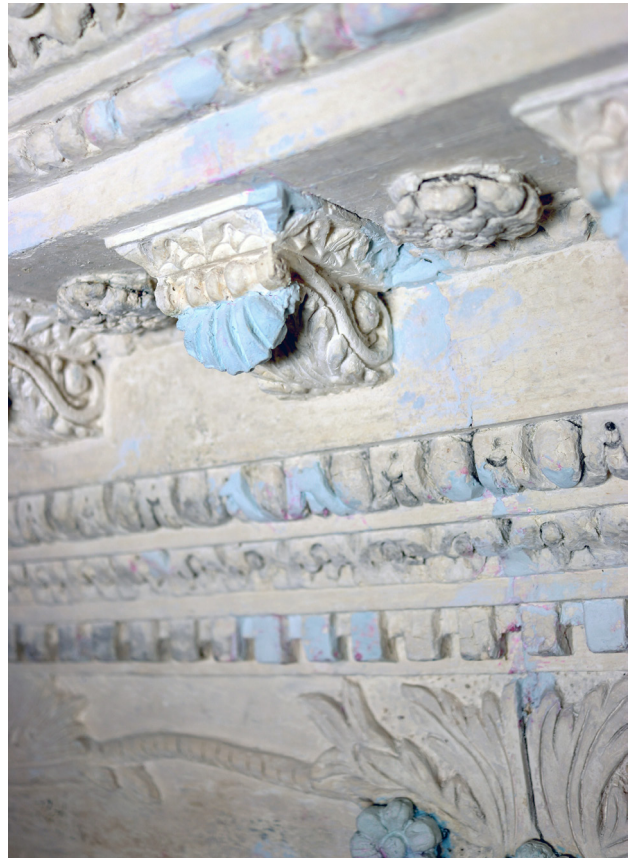
After treatment

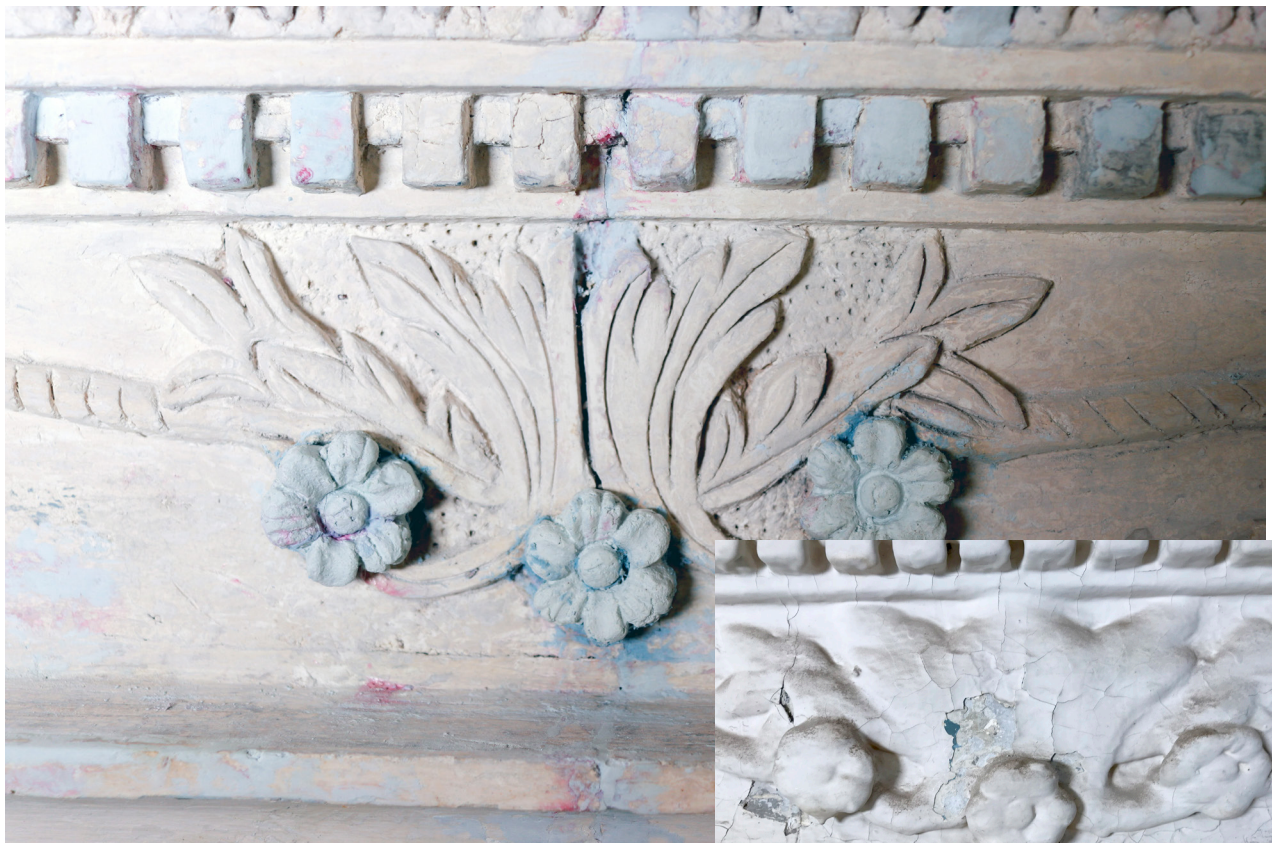
After treatment with replacement

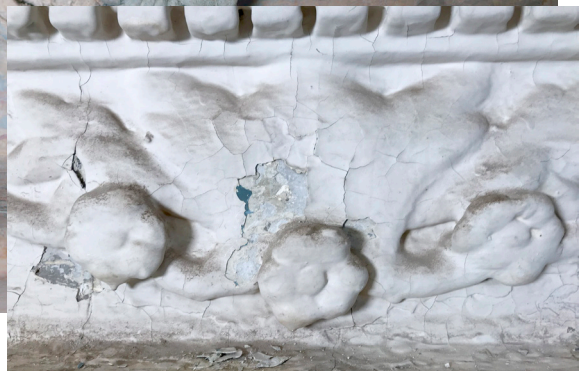
Before treatment conditions

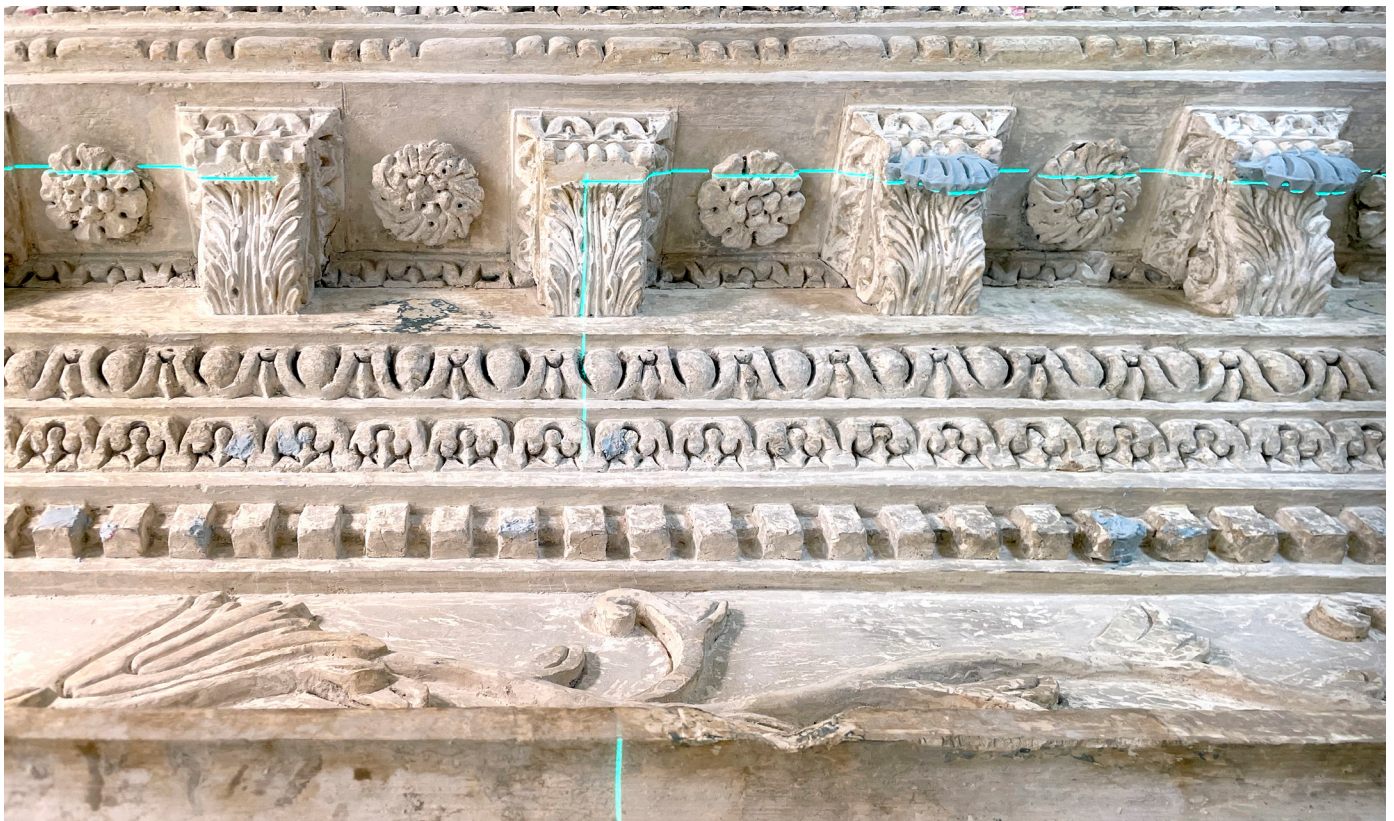
During repair and element replacement

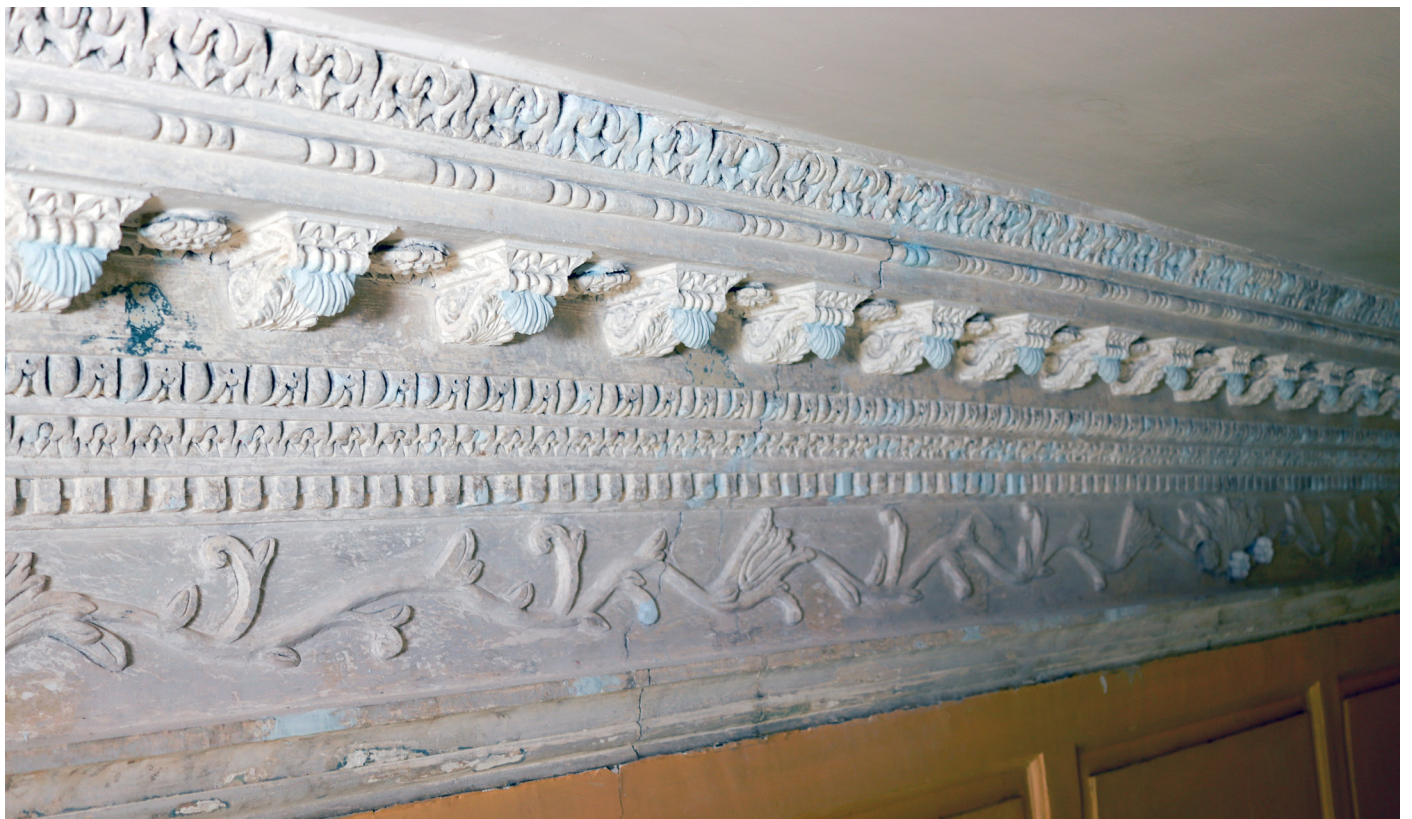
After treatment
