Sand Characterization for Sand-Paint  
Second-floor South west Chamber Mantel  
Gunston Hall  
Mason Neck, Virginia

Prepared by: Christopher Mills, AIC, PA  
Architectural Conservator  
November 15, 2010

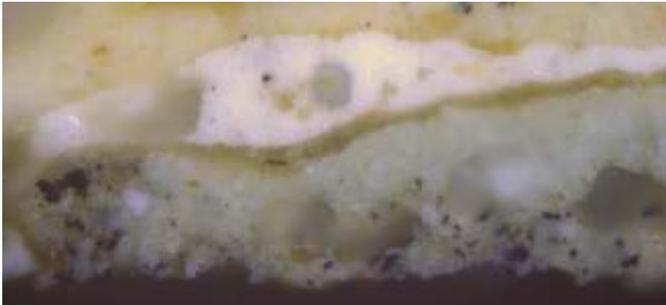
Sample #2 Mantel/From architrave, edge right below curved molding

The two photomicrographs below are by Susan Buck from *Cross-section Paint Microscopy Report/The Chinese Room and Second-floor Chamber Paints* (pg. 29, and 32), and are used to compare size, shape and color of sand particles in the following photomicrographs.

What is evident from the photomicrographs from the mantel is that some of the sand particles appear to be on or very near the surface suggesting that, like Mount Vernon and Monticello, the sand was, in part, presenting on the surface and not solely imbedded in the paint. This would suggest that the sand was thrown, or blown on during the drying process.

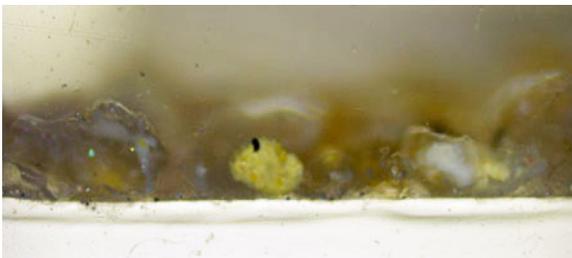
Sample #1 Potomac river sand

1. Potomac River sand /Dry (surface). Taken 10/22/2010 at the historic dock location on bank. Mostly uniform in size, shape. Tan, clear, gray-white.
2. Potomac River sand /Wet (subterranean). Taken 10/22/2010 at the historic dock location at waterline. Samples taken approximately 5" under coarser light sand. Uniform (very small) Gray-tightly packed. Silt-like.
3. White Play Sand from *Colorscape*. Uniform large, smooth and clear to white
4. Masons Sand from *Sakrete*. Very irregular in size, shape and color
5. Texture Aggregate for paint additive from *Zinnzer*. Uniform (small) in size. White.

Of the five samples examined Sample #1- Potomac surface sand and Sample #4 Masons sand most resemble the approximate size, form and color found in the samples from the mantel. It should be noted that the amber appearance seen in samples #1 and #4 are, in part, the foreground clear granules reflecting the tan granules in the background. Although granule color will effect the color of the paint, translucent granules will reflect the pigment color that they are imbedded. (See Mount Vernon exterior).

Although it is impossible to determine the origin of the sand with visual examination of photomicrographs only, it stands to reason that the Potomac sand, with its close proximity to the structure, was the likely the source for construction materials. This is not to say that sample #1 has the same characteristics as 18th Century river sand at the same location. The physical properties may have changed as a result of upriver population and industry, dredging, heavy construction causing unnatural erosions, or more drastically, imported to the site for fill.

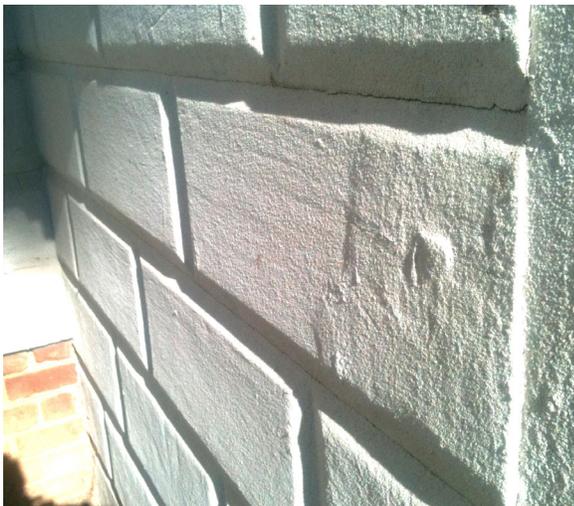
Mount Vernon exterior, clear sand on white ground
