The James Brice House First-Floor Stair Hall: Exposing Faux Wood Graining

The Christopher Mills Conservation team began working on the James Brice House's first-floor stair hall woodwork in April 2022. The goal--to reveal late-eighteenth-century faux wood graining covered by many layers of varnish and oil paint--presented an exciting challenge.

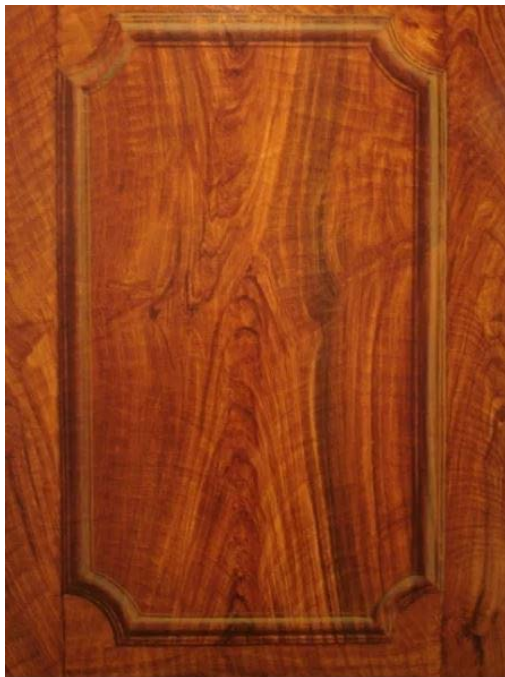
Image 1: An example of faux walnut graining (Source: Art-Faux.com).

A common eighteenth-century practice, faux graining techniques were used to mimic more

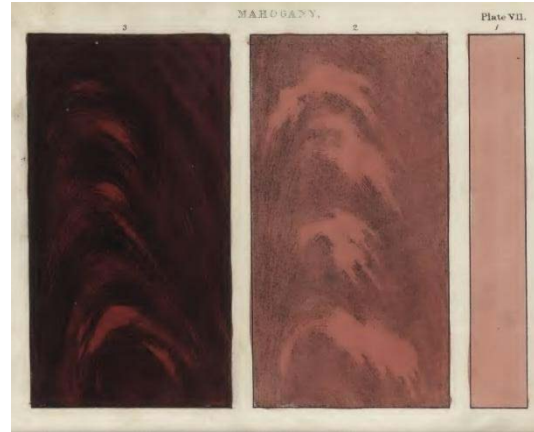
Image 2: Plate showing the step-by-step process of layering finishes to achieve the appearance of Spanish mahogany graining from an 1872 grainer's manual.²

expensive materials (Image 1). The Brice House staircase and hall woodwork are pine, a much more affordable option for James Brice than expensive hardwoods such as oak, walnut, and mahogany. To replicate the desired material, a house painter built up layers of both opaque and translucent finishes (glazes and varnishes) [Image 2].¹

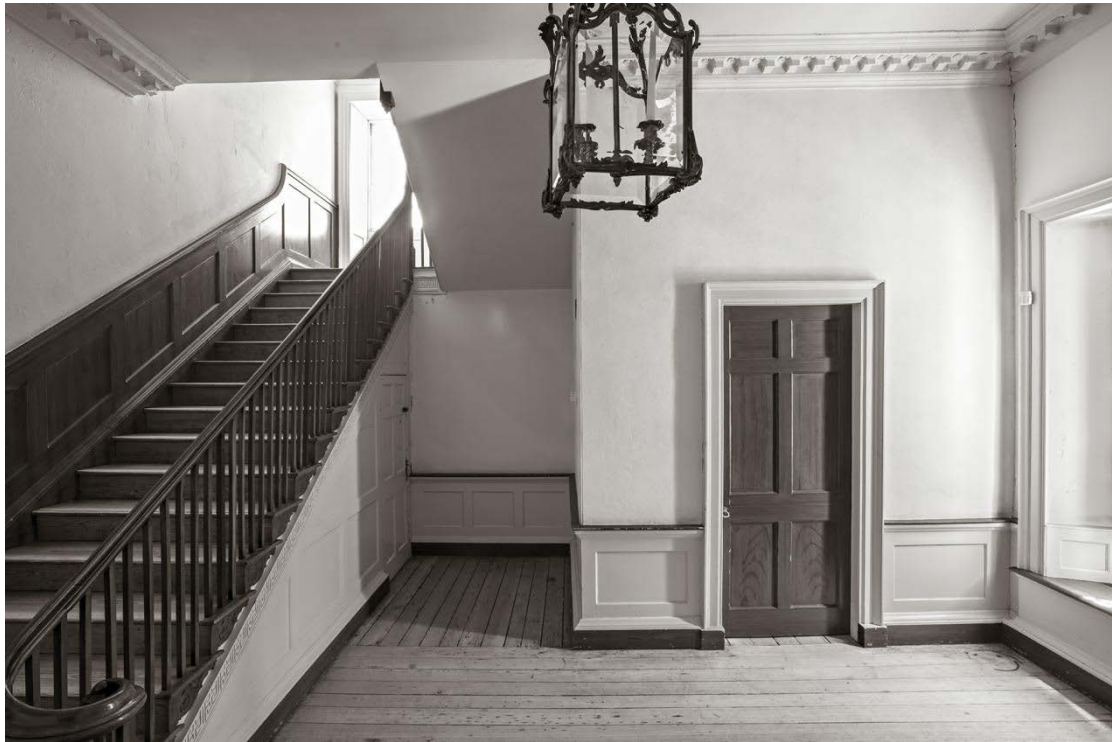
Image 8: The James Brice House first-floor hall and stair hall. The original Georgian-style handrail (far left) remains on the wainscoting. (Source: Willie Graham.)

It can be surmised that these updates likely resulted in the second faux graining campaign. (When the CMC team was ultimately able to reveal the graining, we found that the second campaign was mahogany like the carved brackets.) Interestingly, a Georgian-style handrail that caps the wainscoting survived these changes and remains as evidence of the first iteration of the staircase (Image 8).

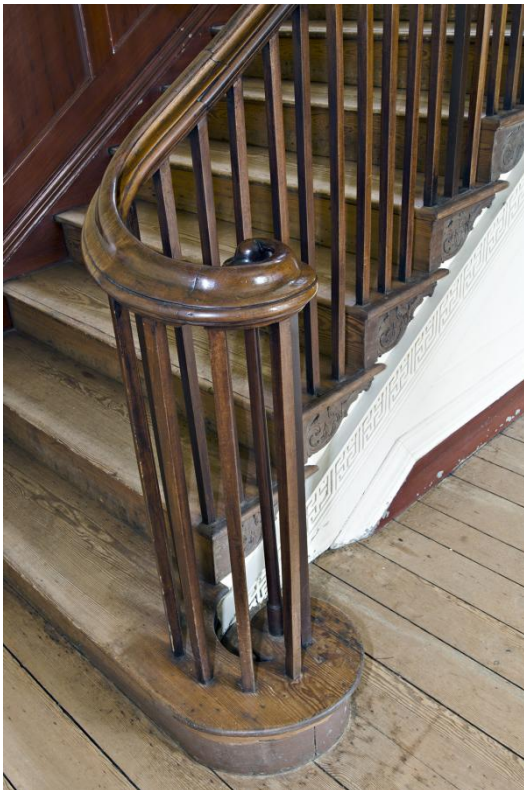
Image 9 (Left): The curving handrail and square balustrades that replaced the earlier Georgian-style elements on the staircase ca. 1773 (Source: Willie Graham).

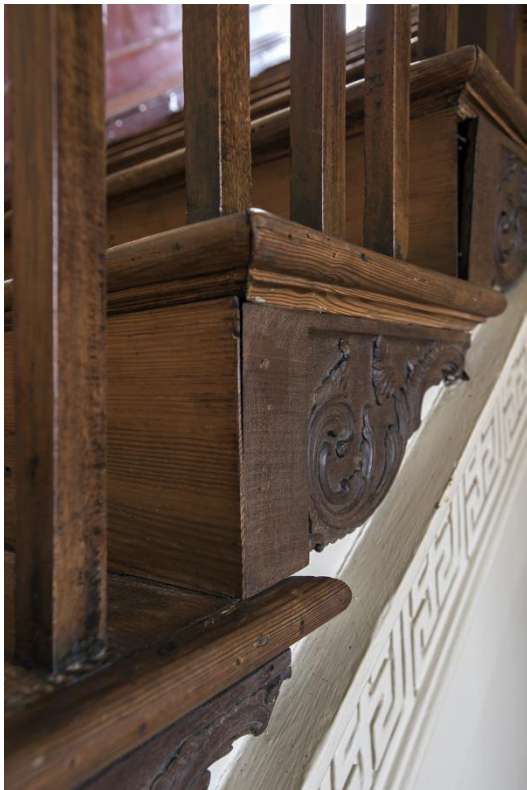
Image 10 (Right): The curved mahogany brackets added to the stairs ca. 1773 (Source: Willie Graham).

James Brice’s personal records along with physical examination of the staircase lend credence to the theory that the faux graining campaigns happened in rapid succession. Stylistic changes made to the staircase likely initiated the second graining campaign while the house was still under construction. According to his records, Brice purchased turned balusters for the staircase in 1768. Visually heavy, turned balusters were typical of a Georgian-style residence. By 1773, the more ornamental Rococo style emerged as fashionable, leaving the Georgian staircase looking dated despite being built only 5 years earlier. The existing balusters and an accompanying handrail were torn out and replaced with the slim, square balusters and a delicate, curving handrail that remain intact on the staircase to this day (Images 8, 9, and 10).⁸ The carved mahogany brackets that serve as decorative fretwork along the stairs were also added at this time (Image 10).

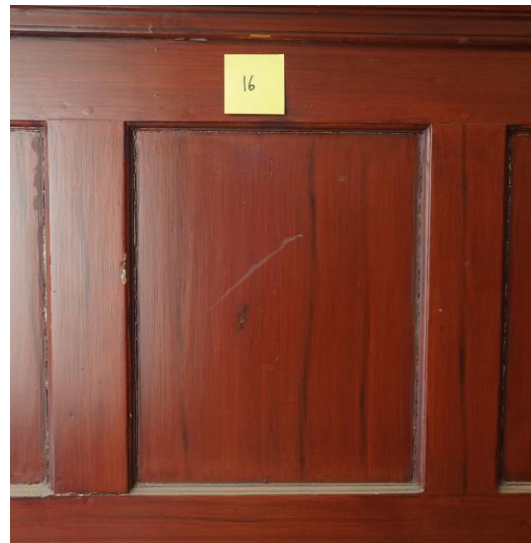
Image 12: The Stair Hall wainscoting before work began. This faux graining finish dates to the 1980s (Source: Taylor Day, 2022).

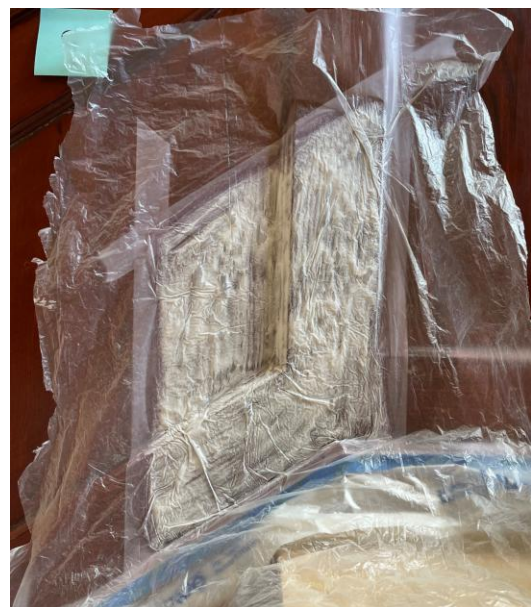
Image 13: A small test section with stripper applied and covered in plastic (Source: Taylor Day, 2022).

The team began testing the stripper's effects on smaller sections of wainscoting before moving onto larger areas (Image 13). Stripper was only applied in increments removable during one workday, including the time needed for the material to dwell. Initially, it was not known if this process of stopping and starting when removing the overpaint layers would impact the appearance of the exposed graining. Therefore, stripper was cautiously applied to an entire architectural element at a time: for example, the inset panels and the horizontal rails and vertical stiles that encase the panels.

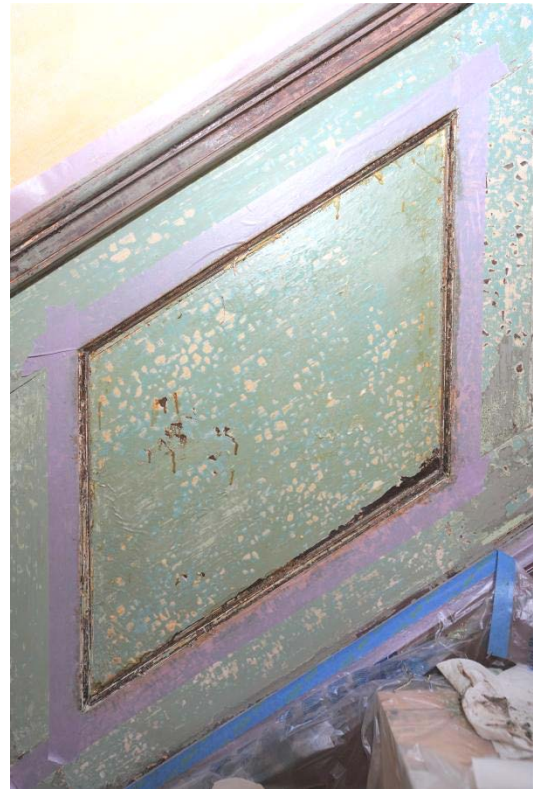
Image 14: A panel stripped using the shorter 2-hour dwell time and wet sanding technique. The brown varnish can be seen weeping in areas where the oil paint layers are missing (Source: Taylor Day, 2022).

In revising our methods for revealing the graining, the team started with a shorter dwell time for the first graining application. Because the maximum dwell time would result in softening finishes as far down as the lead white layers (generations #10-13), we began with a shorter dwell time of 2 hours. This allowed the uppermost layers to detach and easily be removed with a palette knife. Then, to create the

consistent, stable base required for the second application, we used a wet sanding technique (due to the presence of lead) to reach the medium blue and dull green layers. The shorter 2-hour dwell time did not soften these layers.

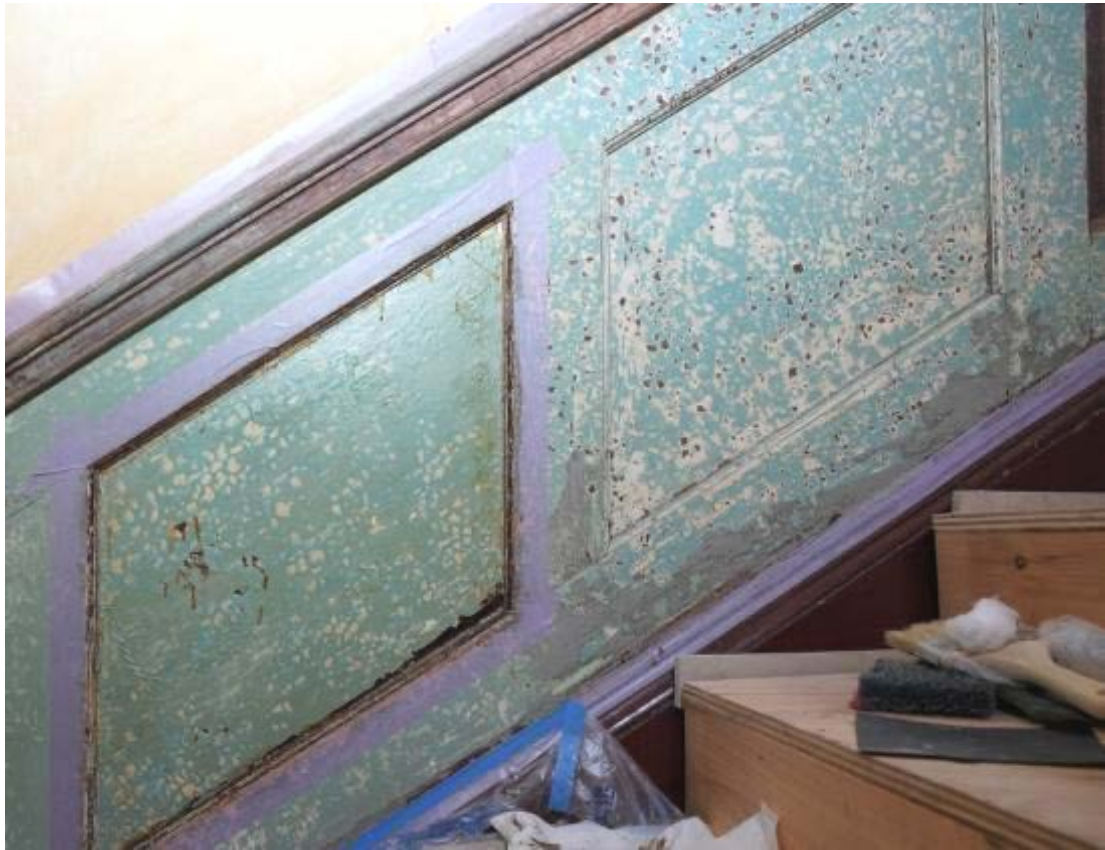
These small, exposed areas of varnish presented an issue because the stripper needed to be reapplied to a relatively consistent layer. Applying the stripper to these inconsistently exposed areas, which the team jokingly referred to as “Swiss cheese,” ran the risk of the damaging whatever remained of the second faux graining campaign. The stripper would work through the varnish layers much more quickly than those still covered with lead white. This left the team with two problems to solve simultaneously: (1) How to safely remove the “Swiss cheese” layers and (2) Developing a new approach to reveal a consistent, stable layer necessary for the second stripper application.

Image 15: Right Panel: A “Swiss cheese” panel stripped before the final method for removing overpaint was developed. The dark spots are the varnish visible beneath the oil paint layers. Left Panel: A panel stripped using the final method, a short dwell time and wet sanding, before the second application of stripper.

The CMC team found that one heavy application of stripper then covered in plastic and given 12-24 hours to dwell easily penetrated as far as the medium blue and dull green layers (generations #14 and #15, respectively [Image 11]). The uppermost layers wrinkled and detached from those below, while those beneath essentially turned into a soft partially liquefied goo. Softened layers were easily removable with a flat #18 X-acto blade and palette knives, which also partially exposed the generations of lead white (layers #10-#13) located beneath the medium blue. Unfortunately, during this process, the overpaint layers were softened enough that small areas including all of the lead white generations also detached, exposing a dark brown varnish (generation #9) [Image 15].

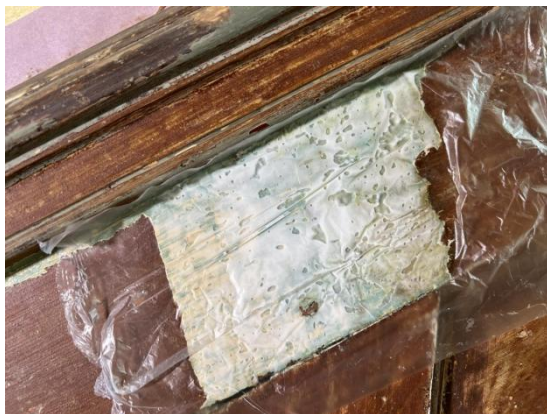
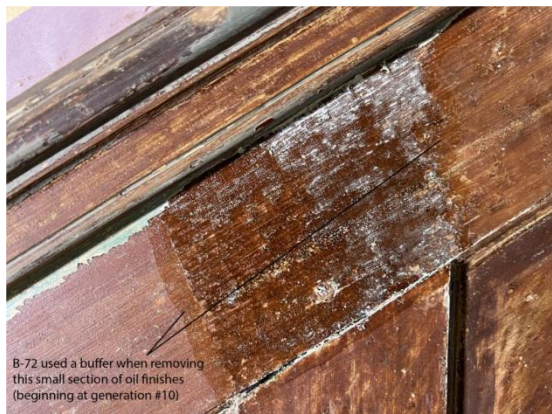
Image 16 (Left) and Image 17(Right): A small patch of partially stripped oil finishes removed using the B-72 method as a buffer (Source: Kelsey Britt, 2022).

To slow the action of the stripper, the team painted in a reversible B-72 adhesive dissolved in acetone to act as a barrier. Once dry, this adhesive is removable with either acetone or ethyl alcohol. Then, the second application of stripper was carefully applied to avoid these areas.

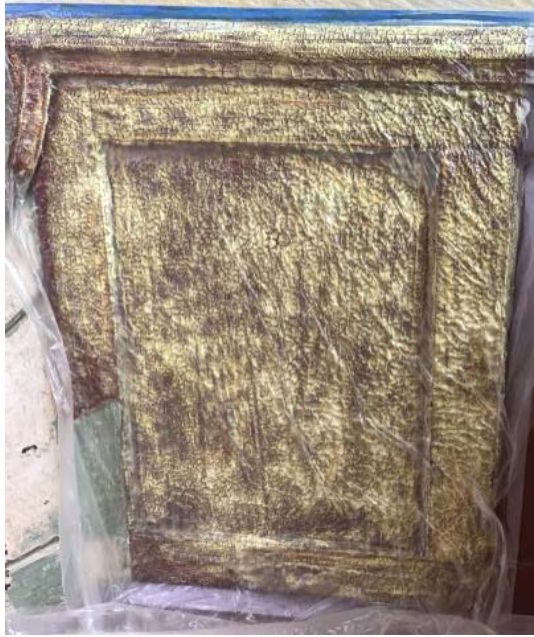
Image 18: First 2-hour application of stripper ready to be removed (Source: Chris Mills, 2022).

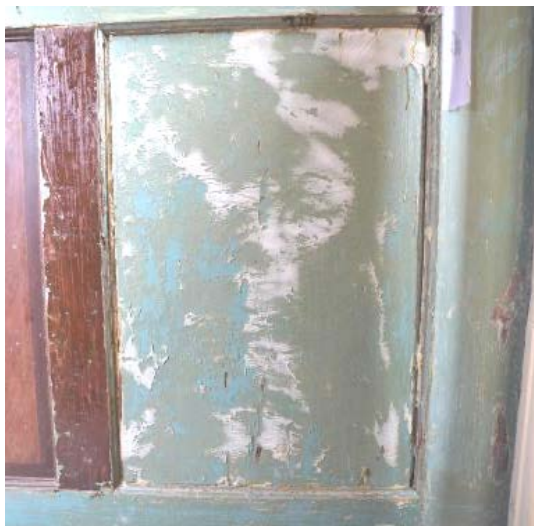
Image 19: The plastic has been removed from this second application of stripper and it is ready to come off (Source: Kelsey Britt, 2022).

The second rounds of stripper were monitored and ready to be removed after 4-to-7 hours depending on the initial dwell time of the section to which they were applied. This second application left the softened oil paint layers essentially floating on top of the varnish layers (generations #4-9), which became liquefied and runny. Caution was exercised when using an X-acto #18 blade and/or palette knife to remove the softened oil paint layers, which could gently be lifted and pulled away from the varnish, sometimes even falling away from the wainscoting due to gravity.

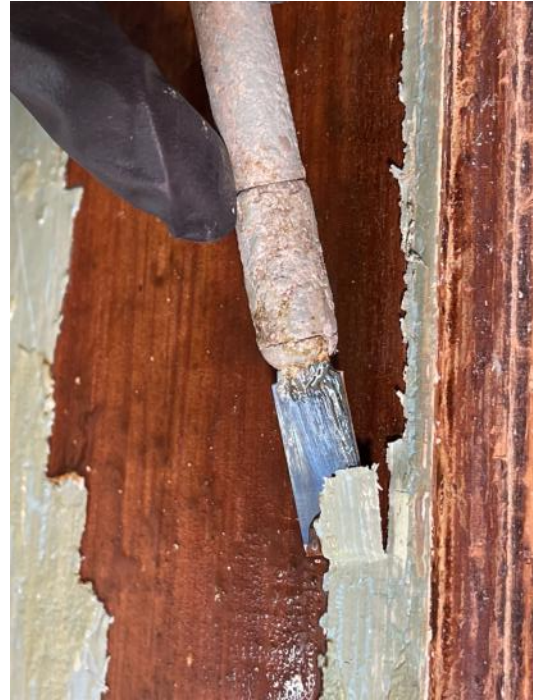
Image 20: Easily removable oil paint layers (Source: Kelsey Britt, 2022).

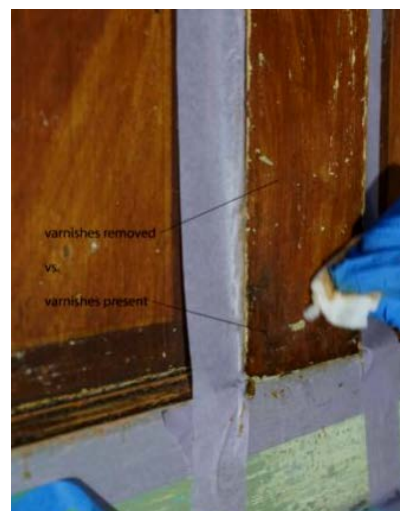
Image 21: Varnish being removed from a stile using a cotton fiber pad and acetone (Source: Taylor Day, 2022).

With time and experience, the exposed varnish was left to dry down overnight and removed the following morning, leaving the layers beneath the varnish more stable and less likely to be disturbed. The cotton batten and skewer method was also abandoned in favor of cotton fiber pads and acetone with the capacity to remove more varnish at one time and did not leave residue behind.

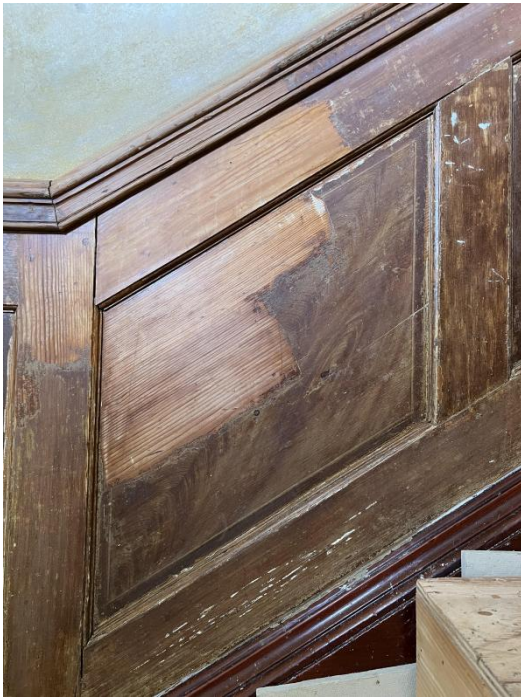
The level to which the faux graining remains varies between the wainscoting's architectural elements. During the Brice House's 1950s-era renovation, one panel's finishes were partially burned off, leaving only the pine substrate (Image 22). On other portions of the wainscoting, the second graining campaign is more faint or is missing, revealing the layers or pine substrate beneath, while it remains remarkably intact and highly visible on other elements. Because the stair well is a high-traffic area in a home, there is also gouges and scrapes present on the wainscoting. Some of this damage was previously infilled. The handrail, which was frequently touched, retains the least amount of graining.

Image 22: Wainscoting with finishes partially burned off during the 1950s (Source: Kelsey Britt, 2022).

With the faux graining now revealed, the team is working to preserve what we have uncovered, in-paint faded or missing portions of the graining, and recreate what has been lost with the evidence we have (i.e., the panel that was burned during the 1950s).

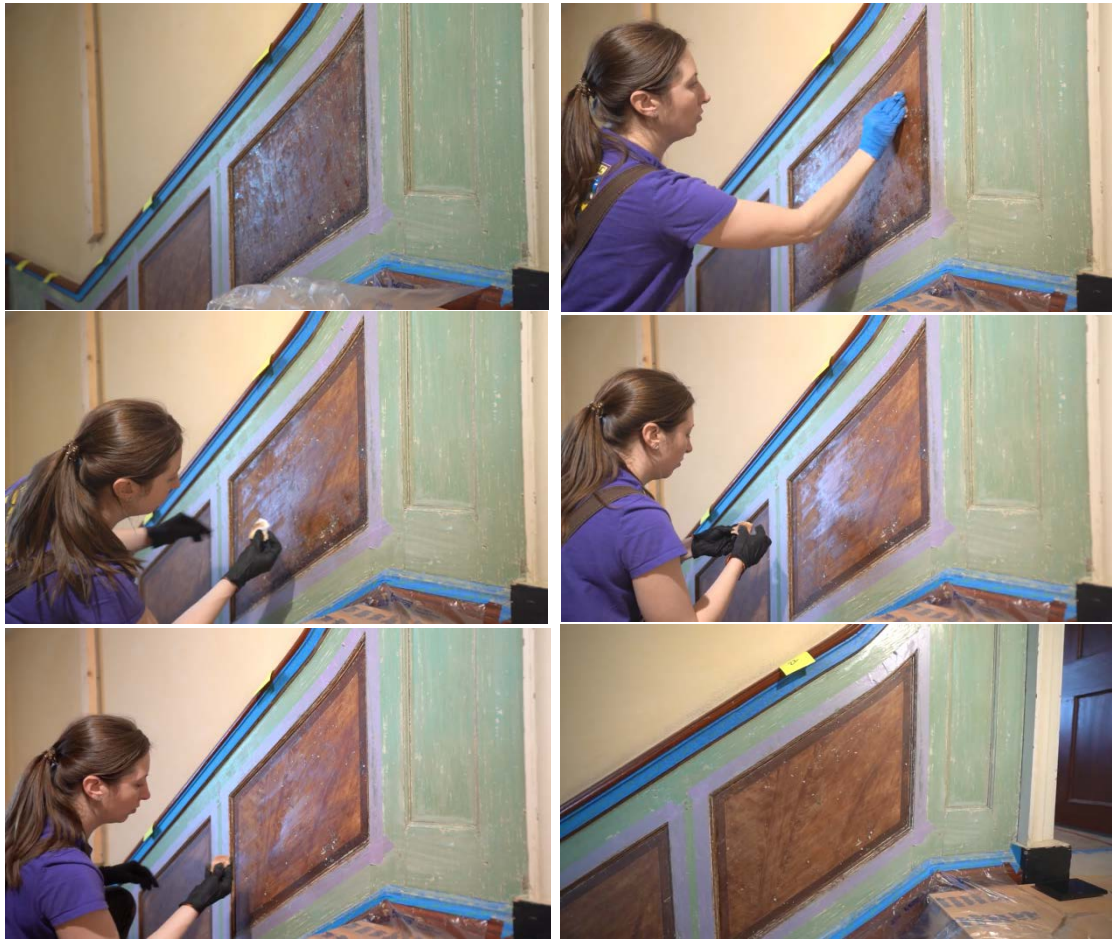
Images 23-28: Progressive video stills showing varnish being removed to reveal the second graining campaign. The varnish layers have a much higher gloss level than the faux graining and are easy to differentiate from the graining due to the way they reflect the light (Source: Kelsey Britt, 2022).

To the CMC team's delight, the varnish layers (generations #4-9) provided a protective buffer between the second faux graining campaign and the oil paint layers. Astonishingly, removing the varnish revealed soft, faux graining done in distemper to imitate mahogany in remarkably good condition.

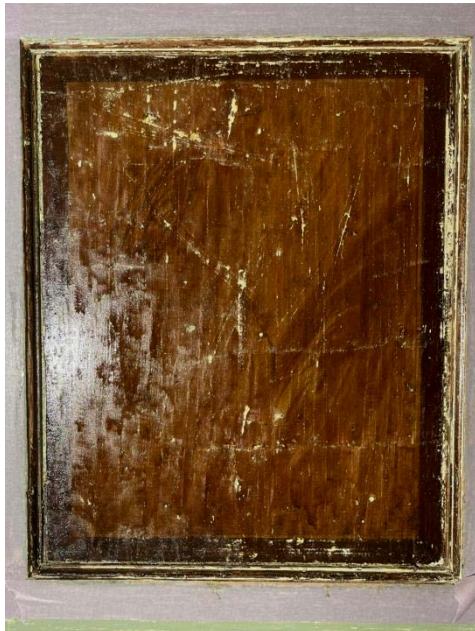
Image 29 (Left): A panel before the varnish is removed (Source: Kelsey Britt, 2022).

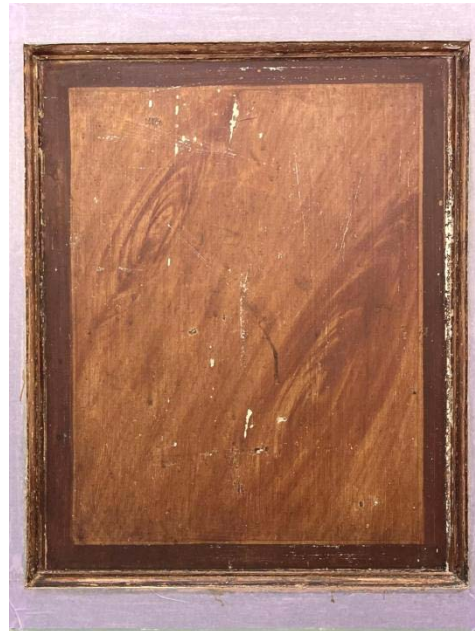
Image 30 (Right): The panel after the varnish is removed, leaving oil paint islands that will require additional stripper to remove (Source: Kelsey Britt, 2022).

The panels required additional cleaning after the varnish was removed. In some areas, small islands of oil finishes required additional rounds of stripper to remove. Small flecks of oil paint dotting the panels, stiles, and rails were removed with a #15 scalpel blade. The wainscoting also required additional cleaning with acetone; often, dirt becomes trapped between layers of finishes and its presence left a green cast on the graining.

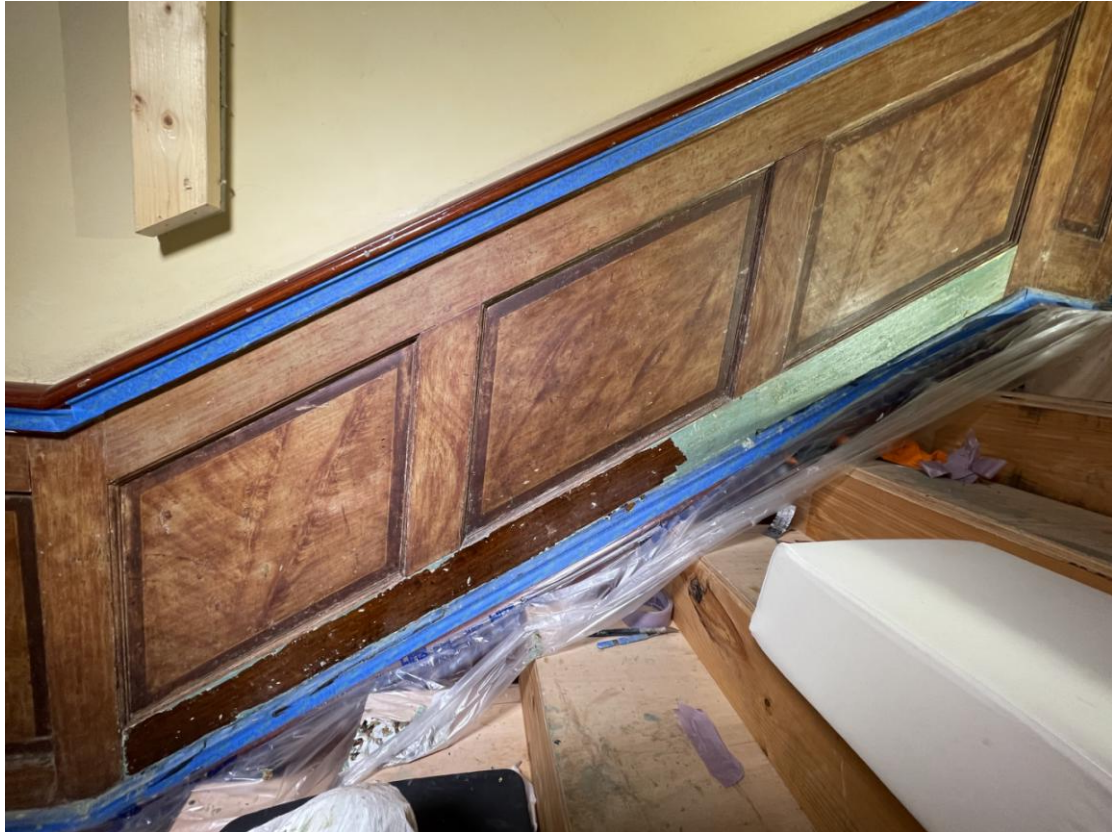
Image 31: The wainscoting that parallels the stairs from the first floor to the landing. The second graining campaign layers are missing in the very light areas (Source: Taylor Day, 2022).

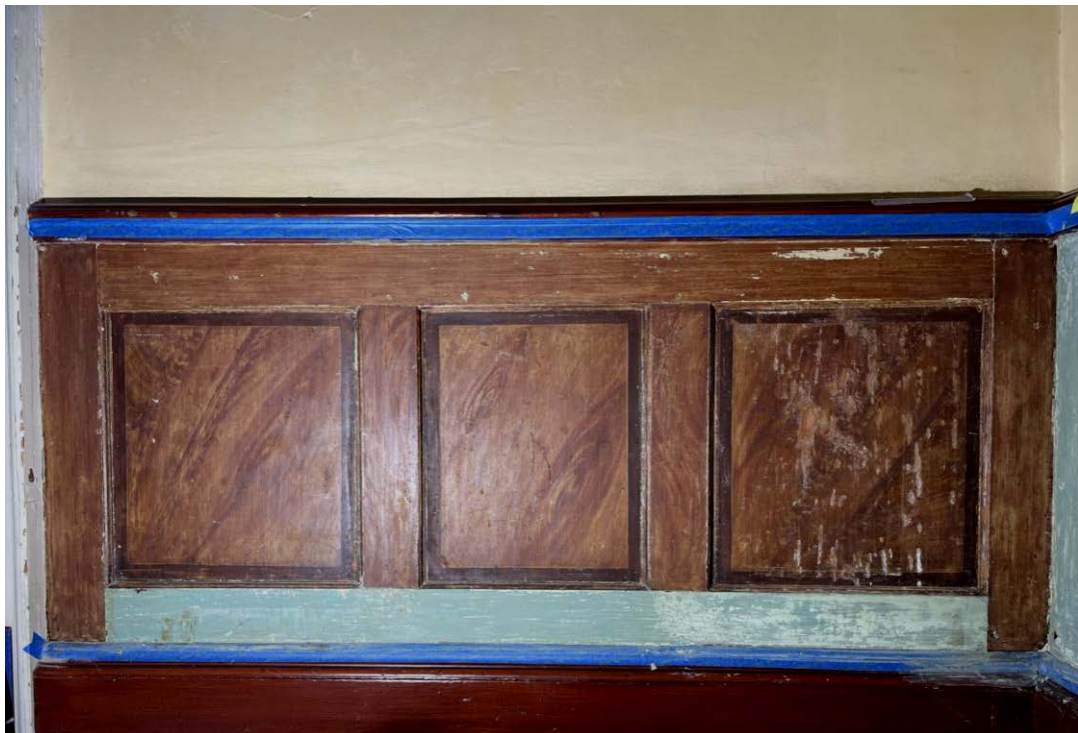
Image 32: Wainscoting on the stair landing. The panel on the right is the most heavily damaged among all of the Stair Hall panels (Source: Taylor Day, 2022).

The majority of the damage to the panels consists of gauges, which can easily be filled. Expansion and contraction caused by moisture fluctuation has caused one panel severely to detach from a stile, but otherwise, the rest of the damage to the wainscoting appears cosmetic.

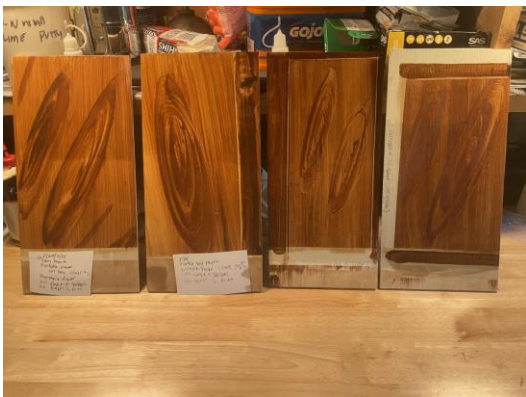
Image 34: Mock-ups made as we work out the process and technique used by the original grainer (Source: Chris Mills, 2022).

In areas where absolutely no finishes remain, the faux graining will be recreated using the same materials--a light-colored base coat followed by pigmented glaze layers--and techniques employed 250 years ago (see Images 35 and 36 for an example of recreated graining). It appears that the original design was achieved by laying a ground layer, followed by a reddish-brown pigmented beer glaze to draw in the figure and border (the thin pinstripe that parallels the border would have been achieved by removing glaze while it was still wet), and finalized with another layer of glaze that intensified the color of the work beneath. It is evident that the original tradesman must have worked quickly with a deft hand. By creating mock-ups, the team is able to work on mimicking his graining style (Image 34).

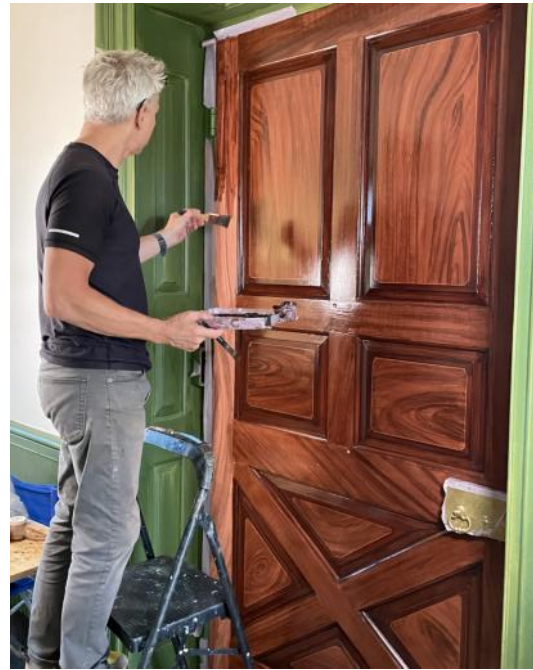
Image 35: An example of recreated eighteenth-century graining on a door at Stratford Hall, Stratford, VA (Source: Chris Mills, 2022).

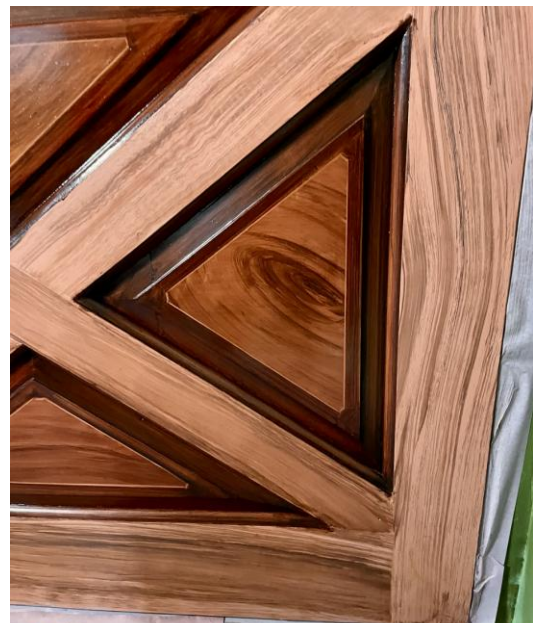
Image 36: Note how much lighter the ground and figure layers on the stiles and rails appear before the final layer of glaze is applied. Stratford Hall, Stratford, VA (Source: Chris Mills, 2022).
