CHRISTOPHER MILLS CONSERVATION SERVICES, LLC

Metropolitan Museum of Art: British Galleries, Kirtlington Park, NYC. c.1745

Casein Paint removal/Substrate and paint consolidation/Application of Hand-made Distemper Paint

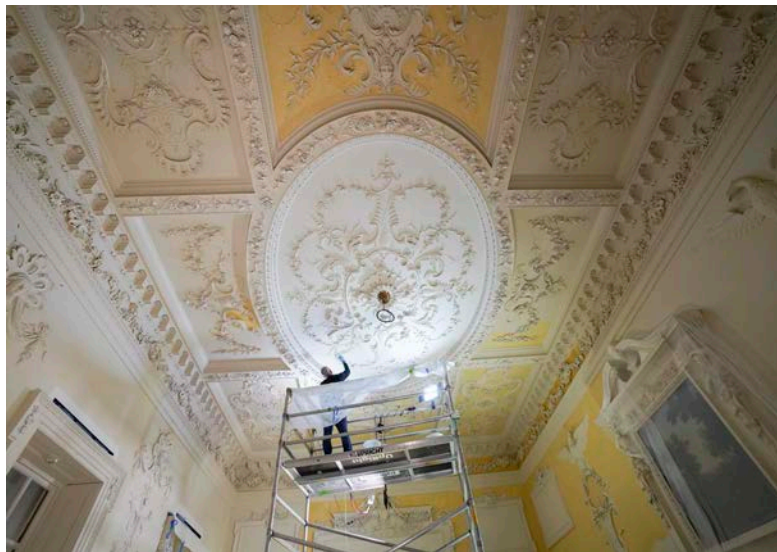
Casein paint removal

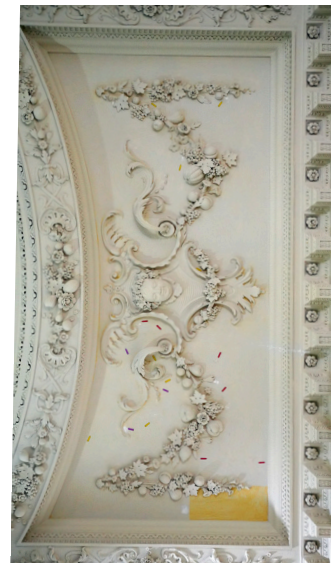
Casein paint removal/ plaster repair

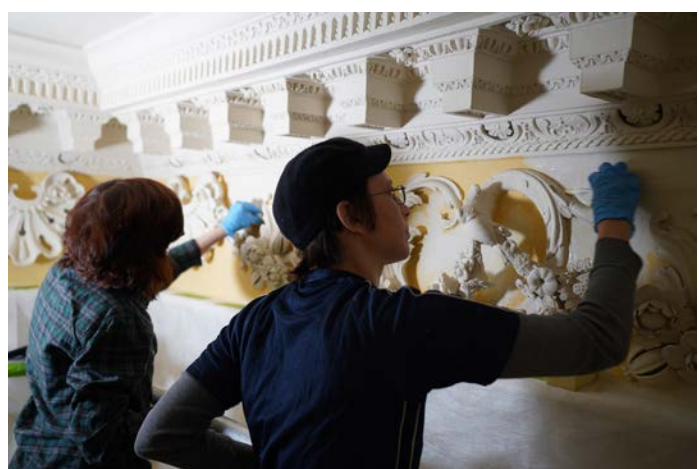
During treatment

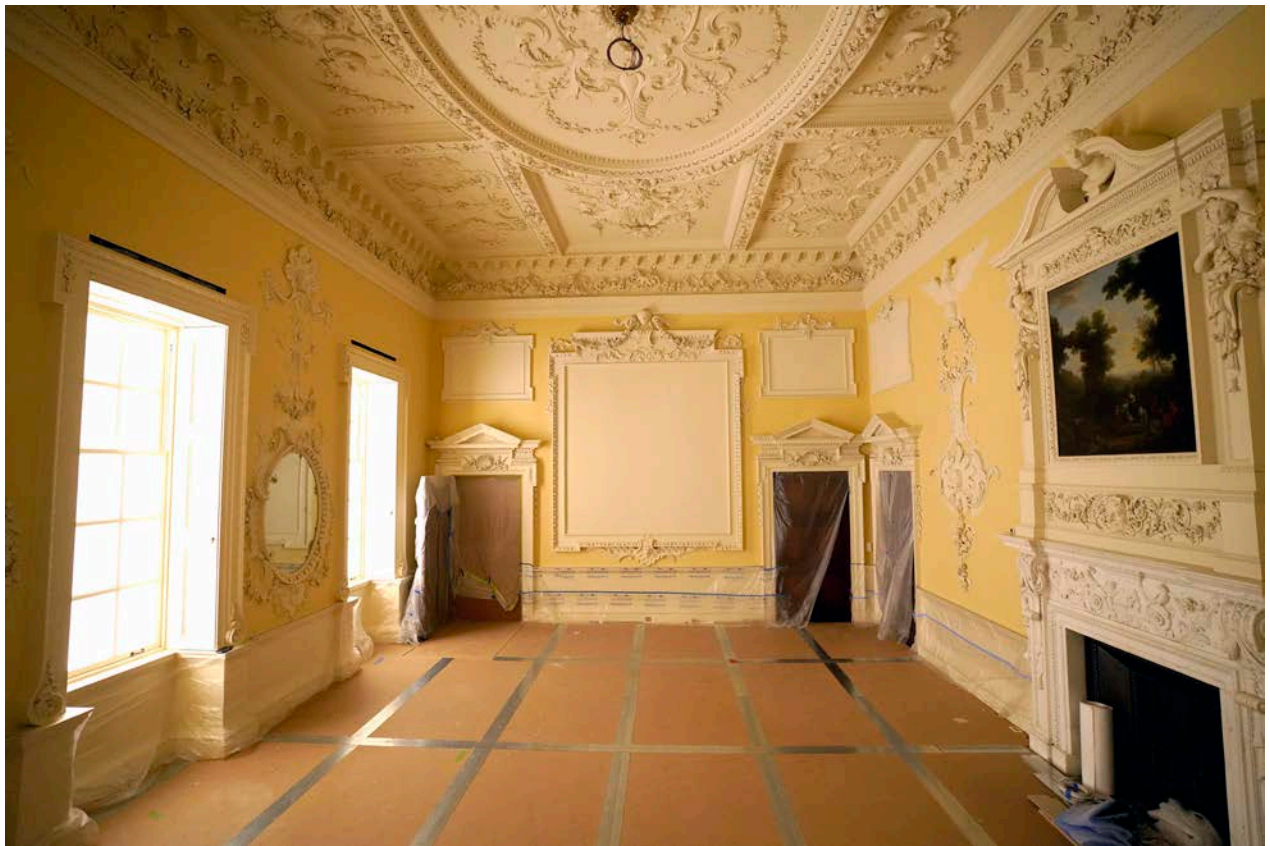
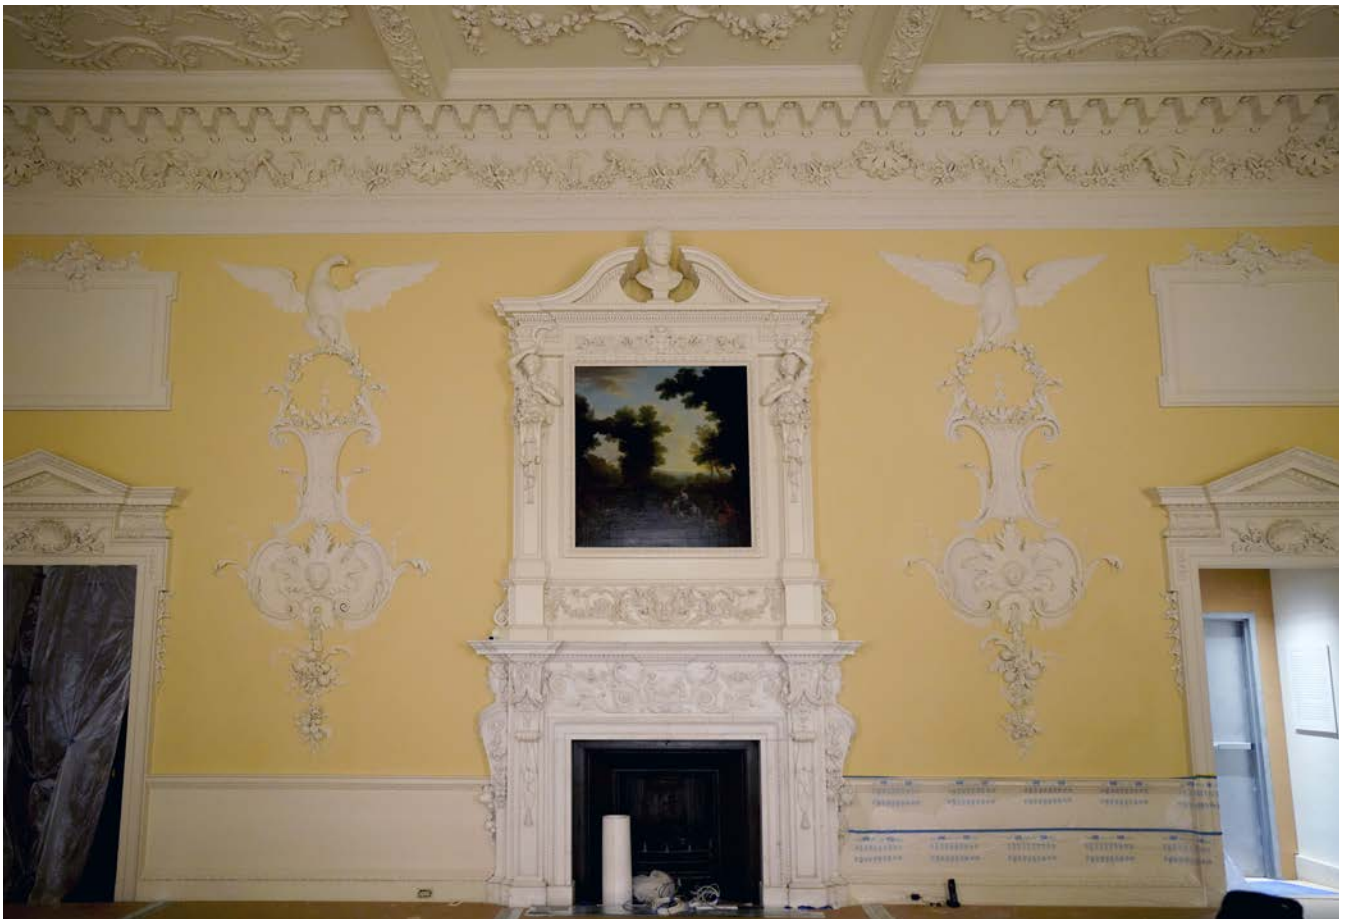
After Treatment

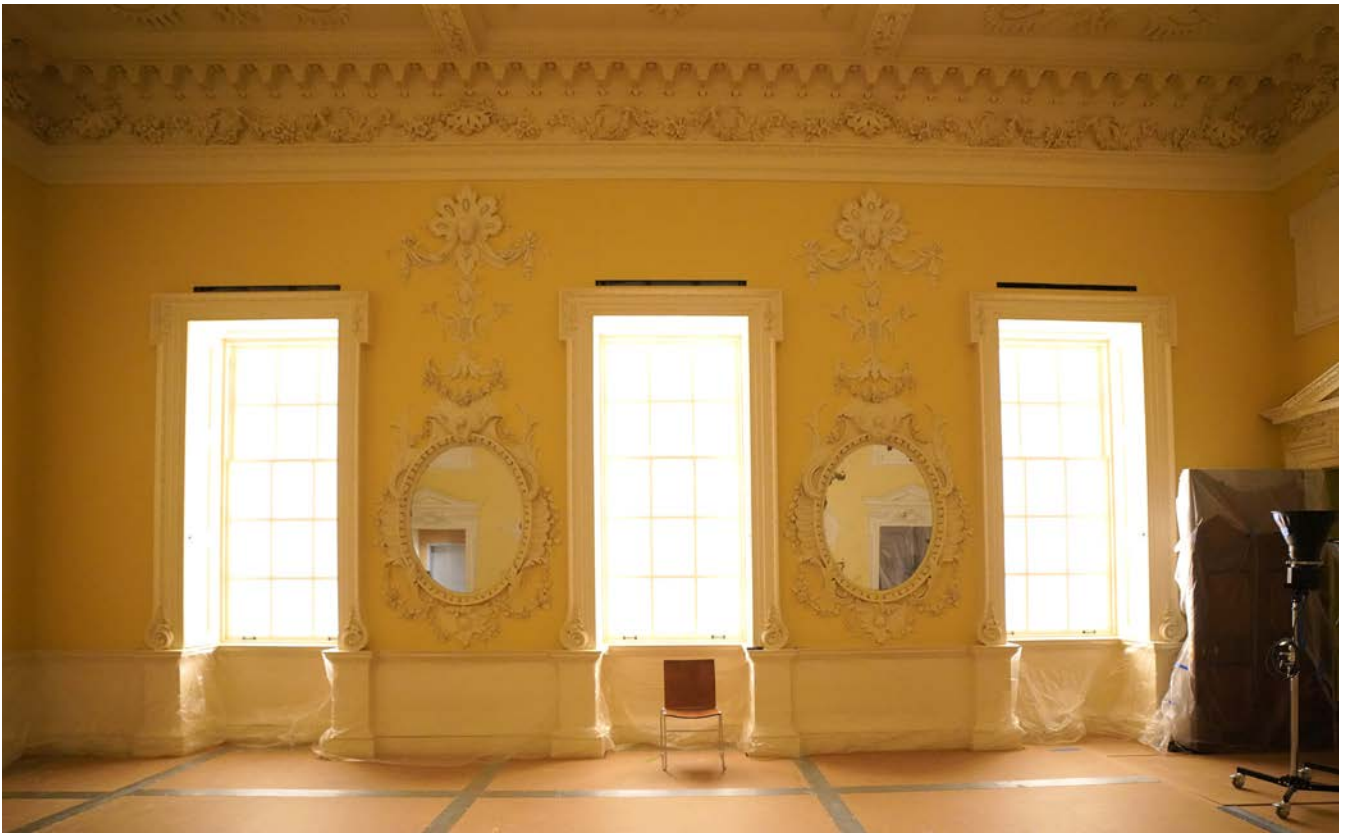
After Treatment

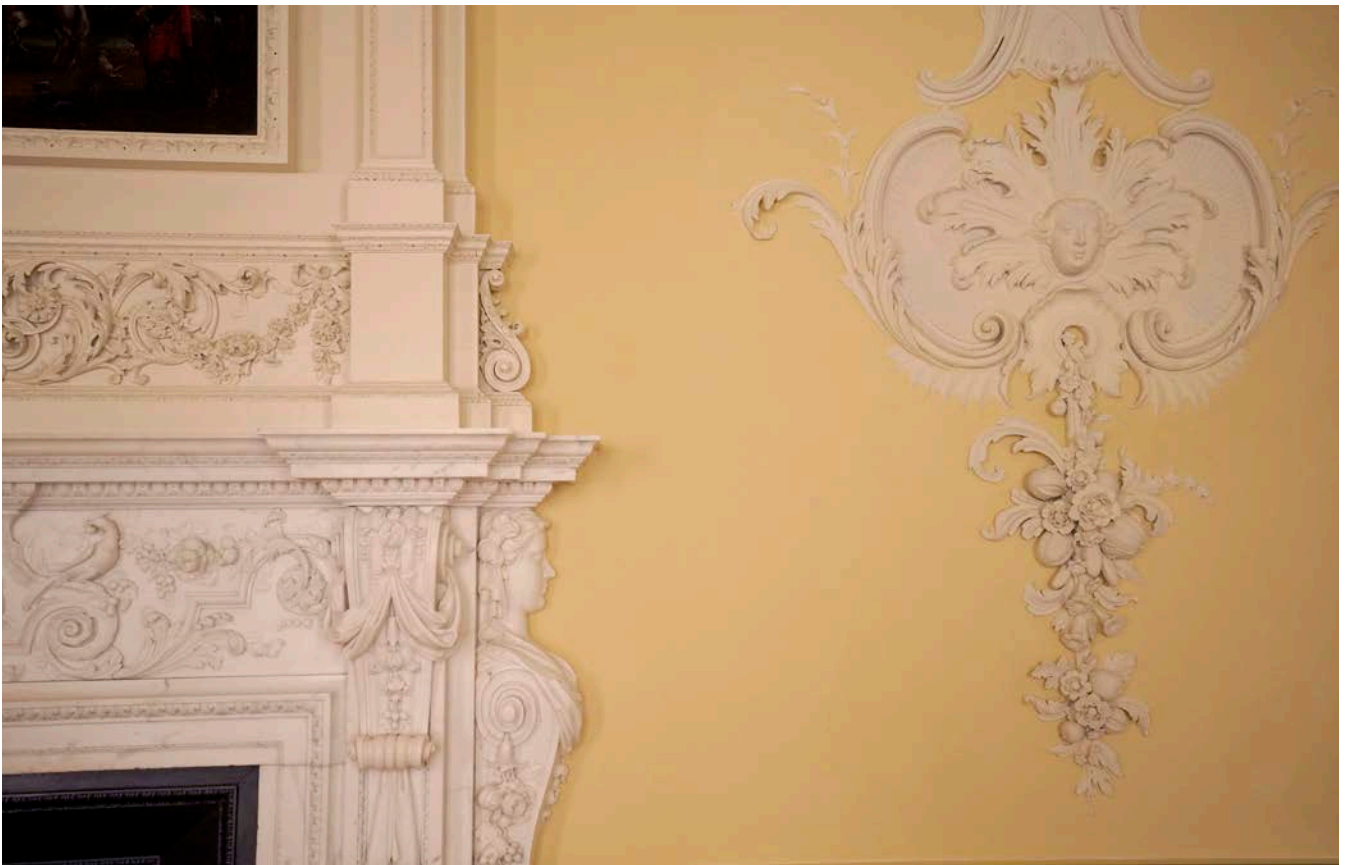
After Treatment
