CHRISTOPHER MILLS CONSERVATION SERVICES, LLC

Thomas Jefferson's Poplar Forest

Application of Hand-Made Distemper, Oil, and Limewashes

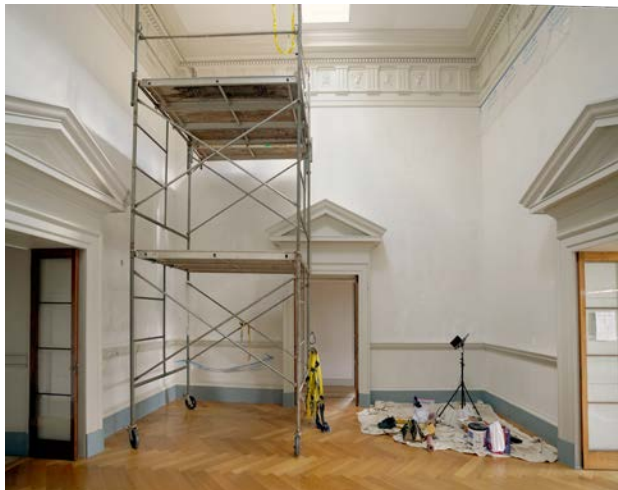
Dining Room before distemper installation

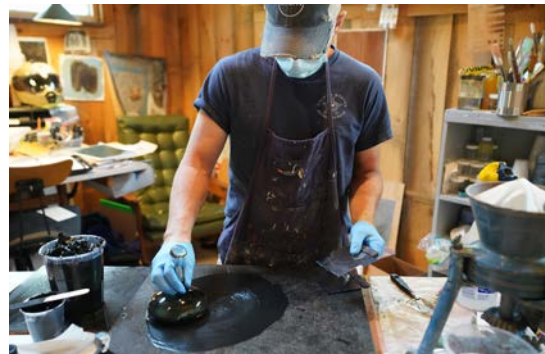
Grinding pigments for distemper

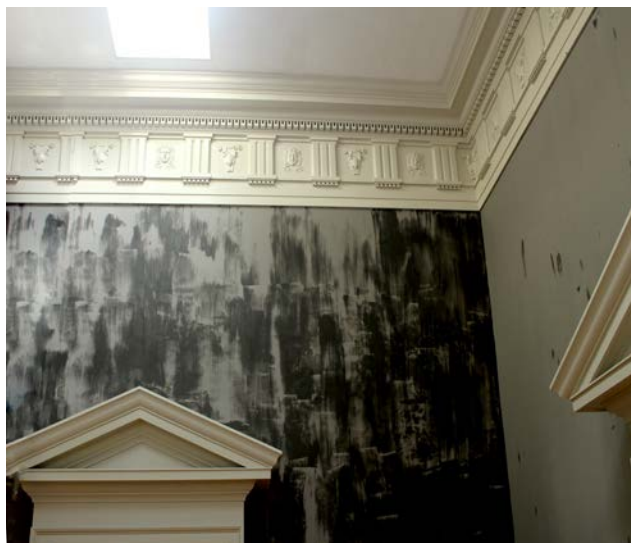
Distemper drying

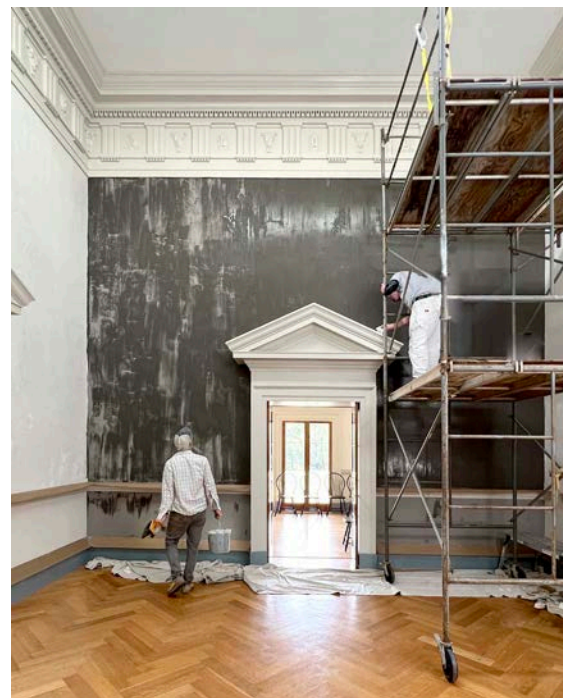
Dining Room distemper application

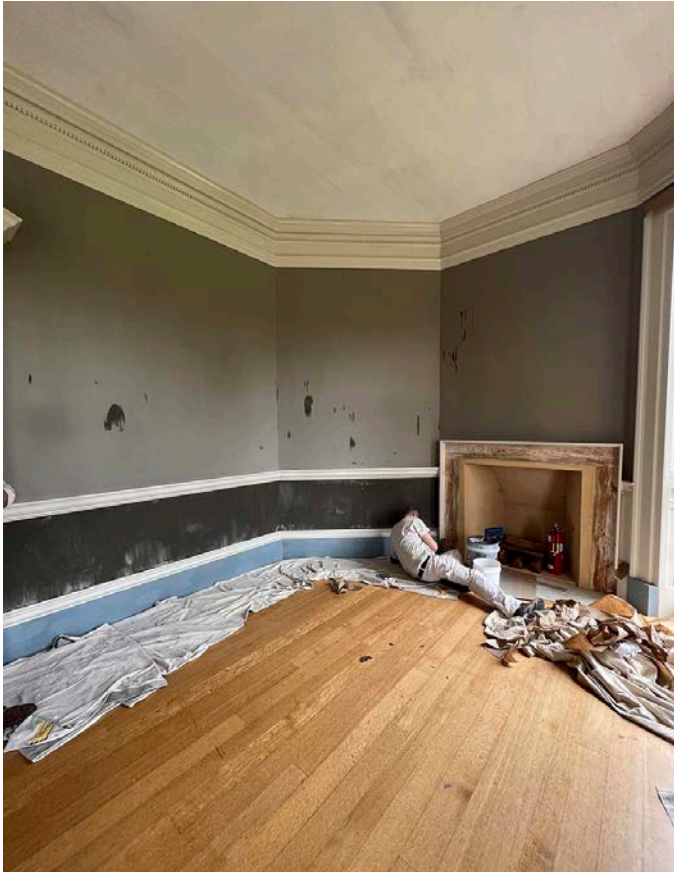
Parlor during distemper application

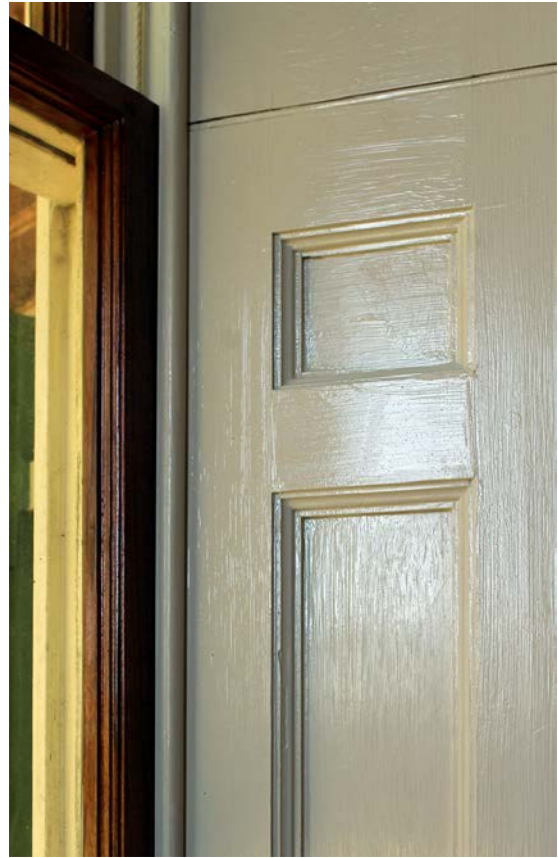
Bedchamber linseed oil detail

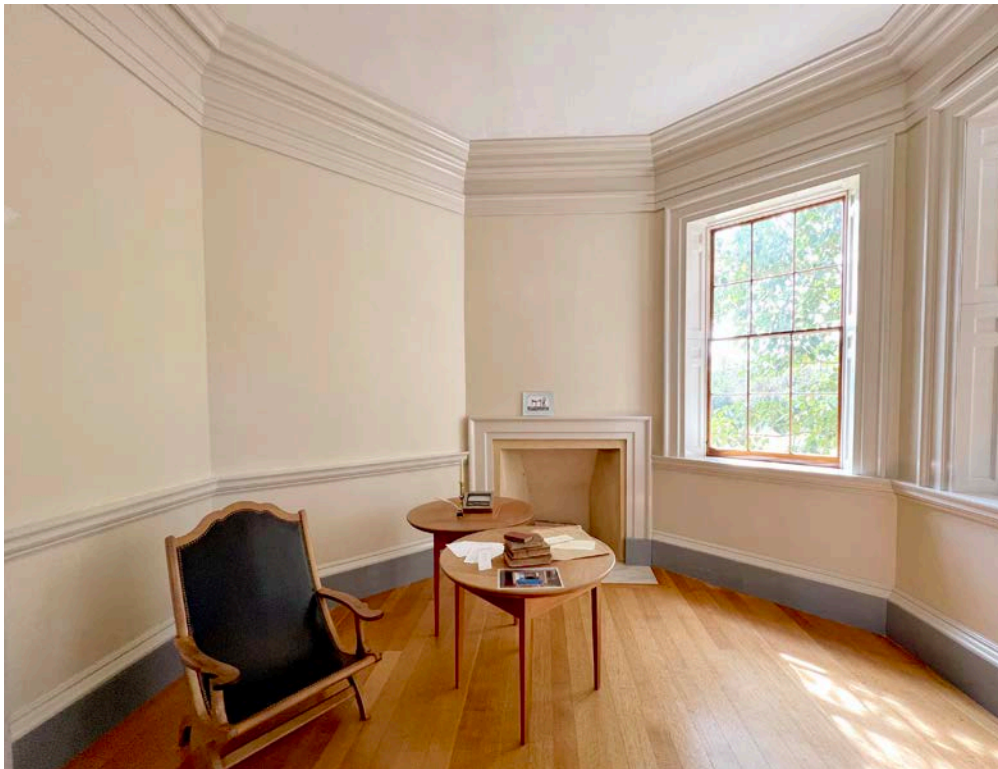
Bedchamber -Linseed oil satin walls and gloss oil woodwork, limewash ceiling

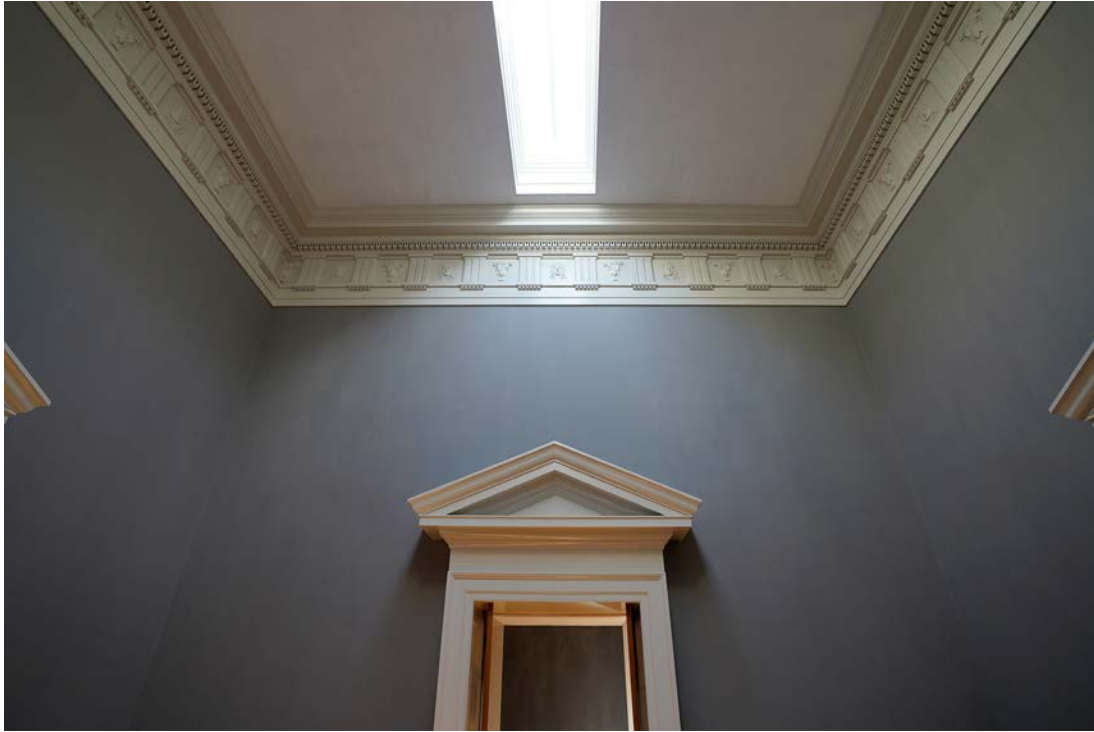
Dining Room -Distemper walls, gloss woodwork, limewash ceiling

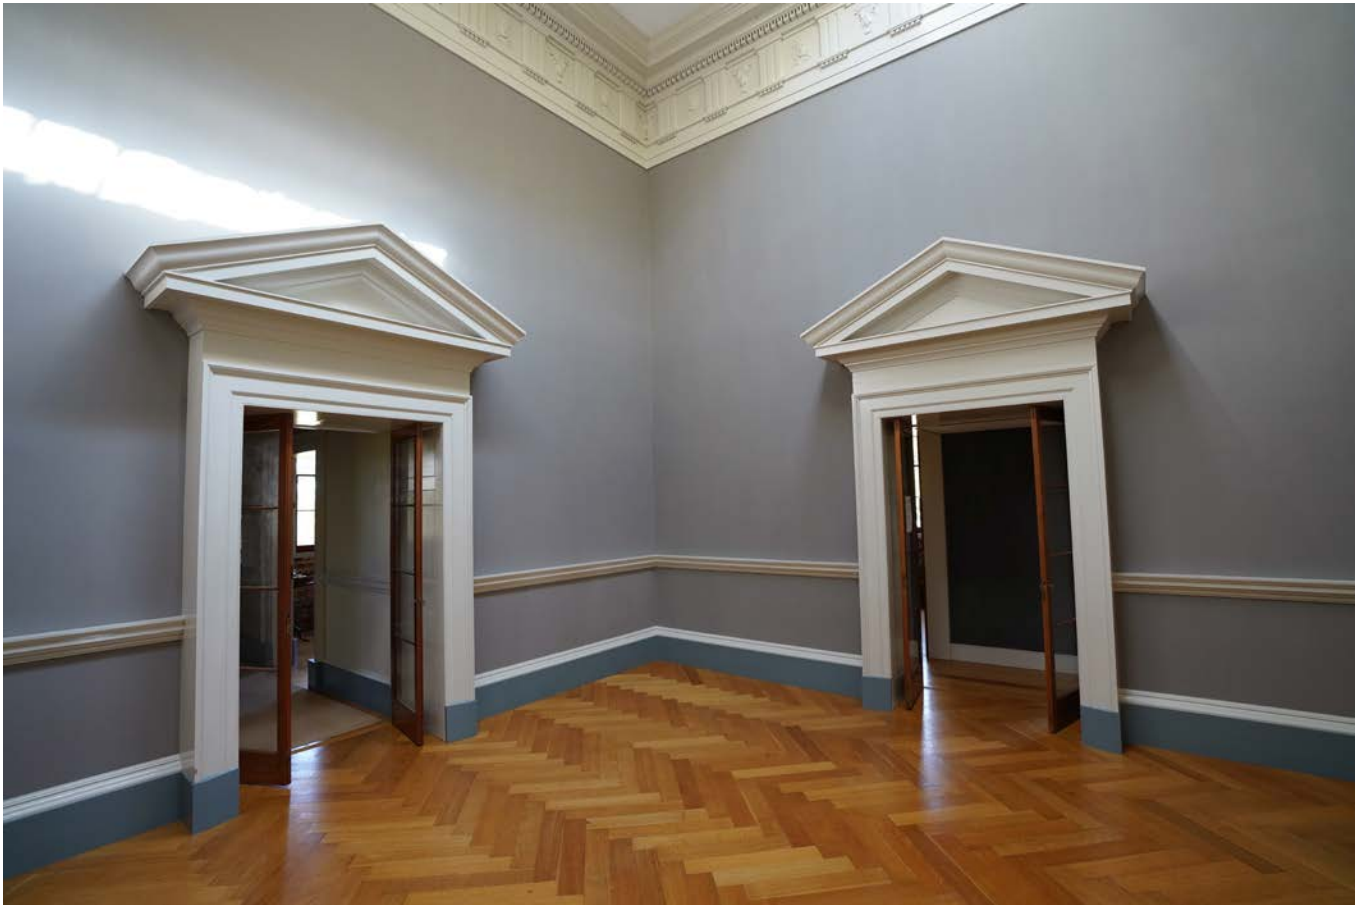
Dining Room finished

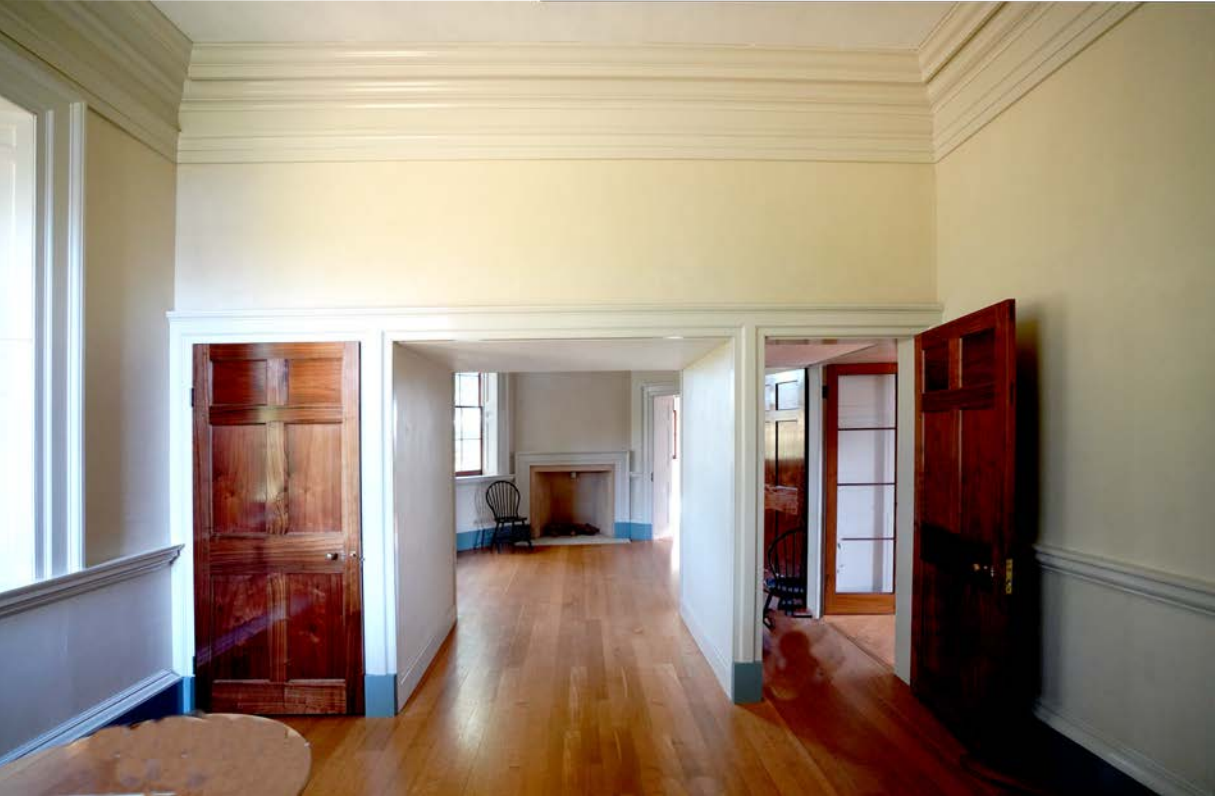
Bedchamber finished

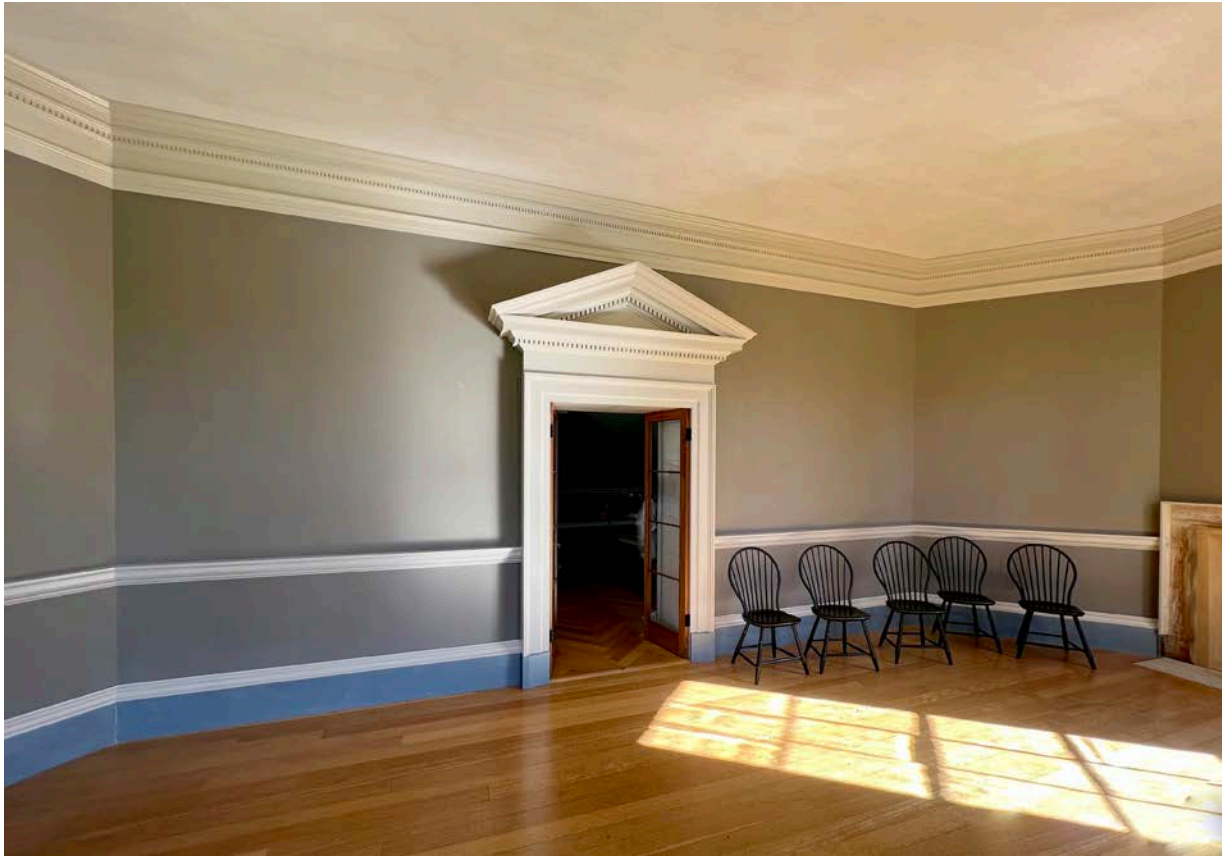
Parlor- Distemper walls and gloss woodwork, limewash ceiling
